# BUILDING INSPECTION NZ

**9th April, 2026**

17 Seccombes Road, Epsom Auckland 1023

# CERTIFICATE OF PROPERTY INSPECTION

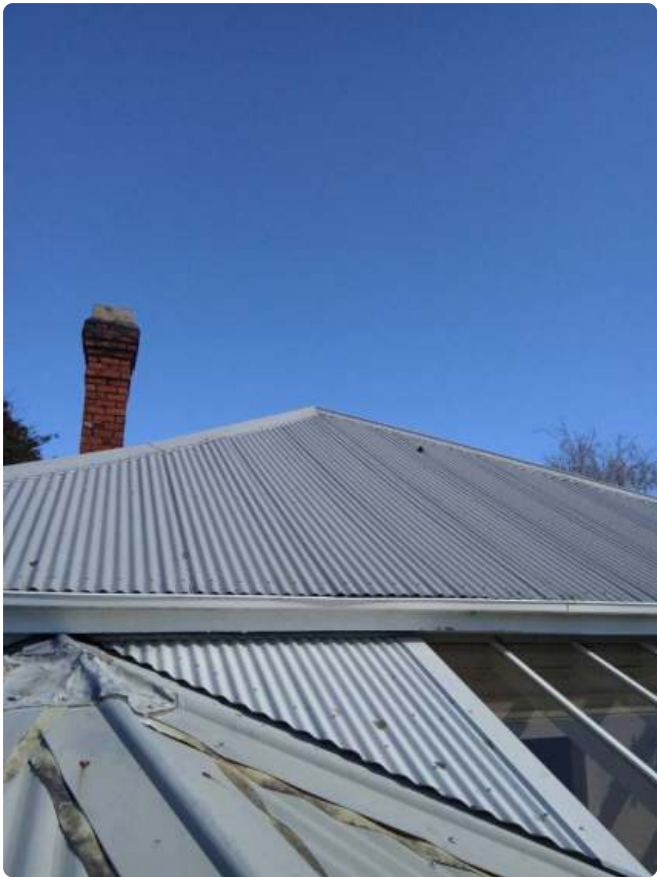
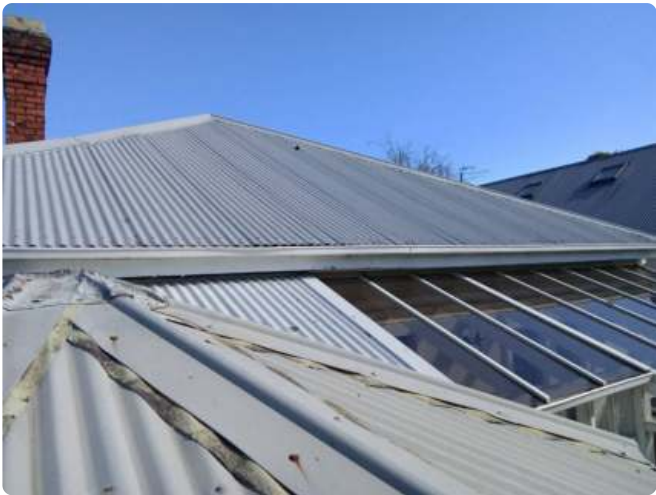
Roof Covering - Continued

Signs of rust. Unable to see closer as driveway slopes and is unsafe for the ladder. Roof is too high.  
Visible sections seem fine

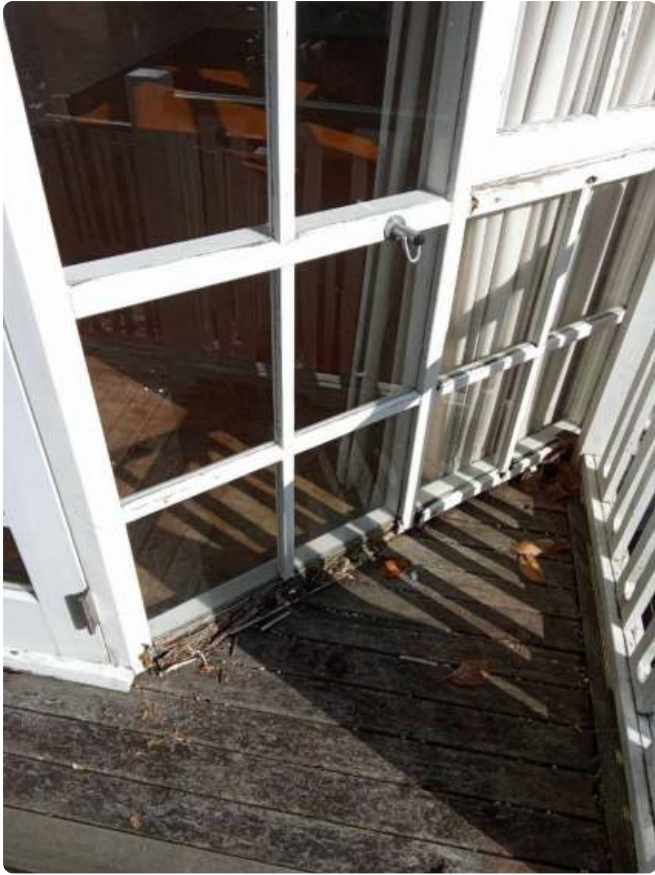
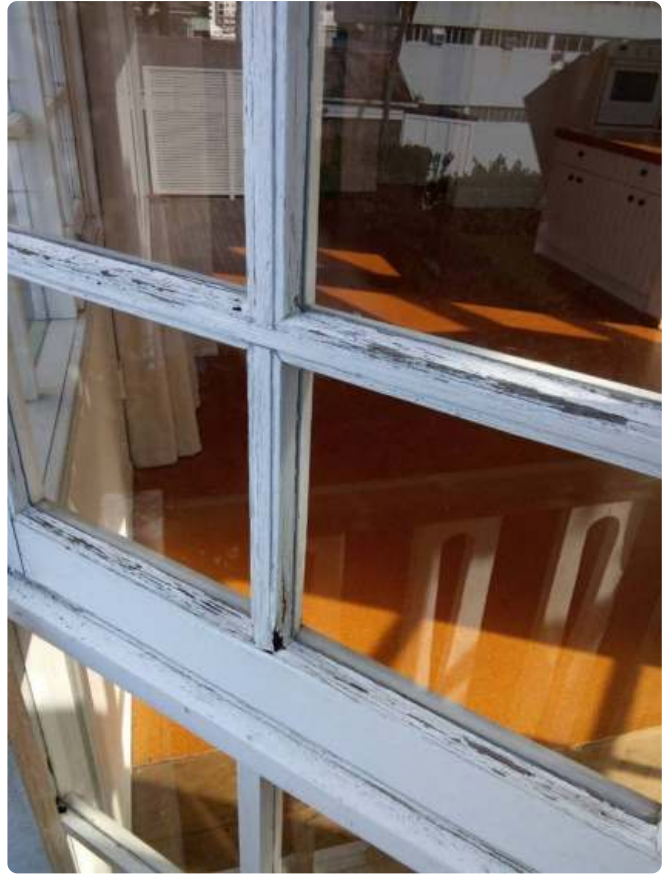
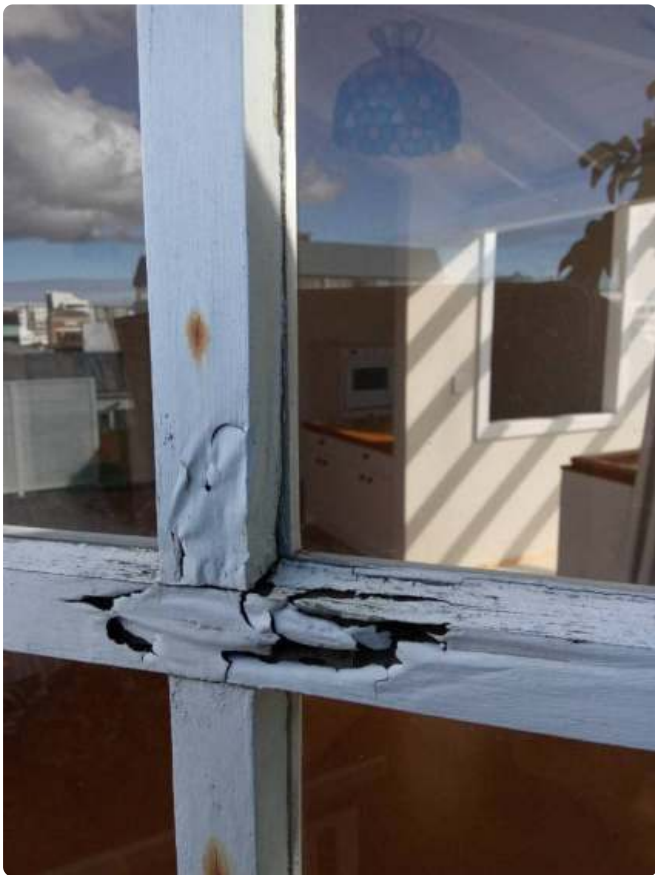
## Windows - Continued

Original sache windows seem fine. Extension part windows and doors are a big concern and may need to be replaced to comply

- Replace or upgrade all non-compliant windows and doors in the extension as required.
- Install extractor fans in kitchen and bathrooms, underfloor insulation, and a damp-proof membrane to meet Healthy Homes standards.

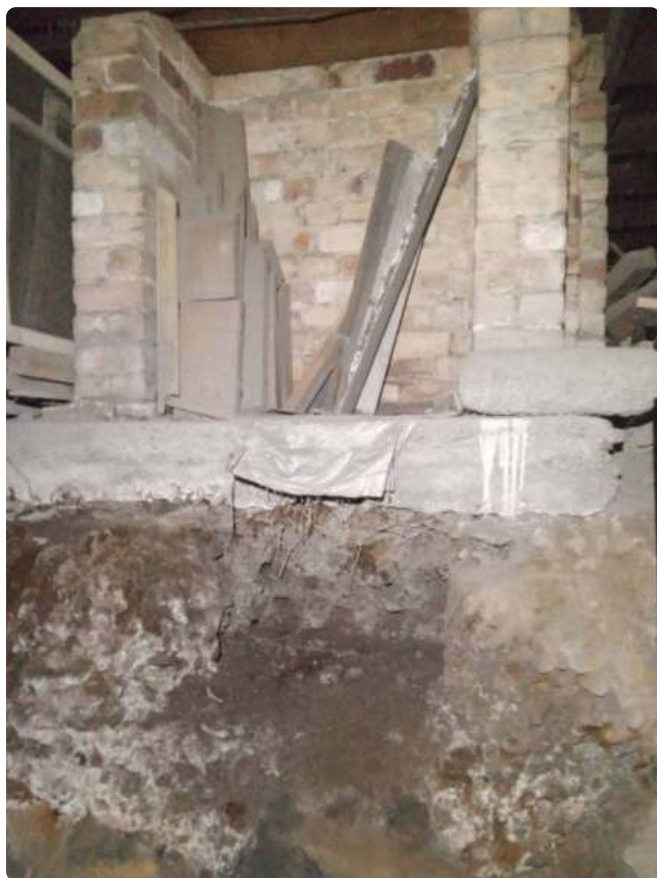
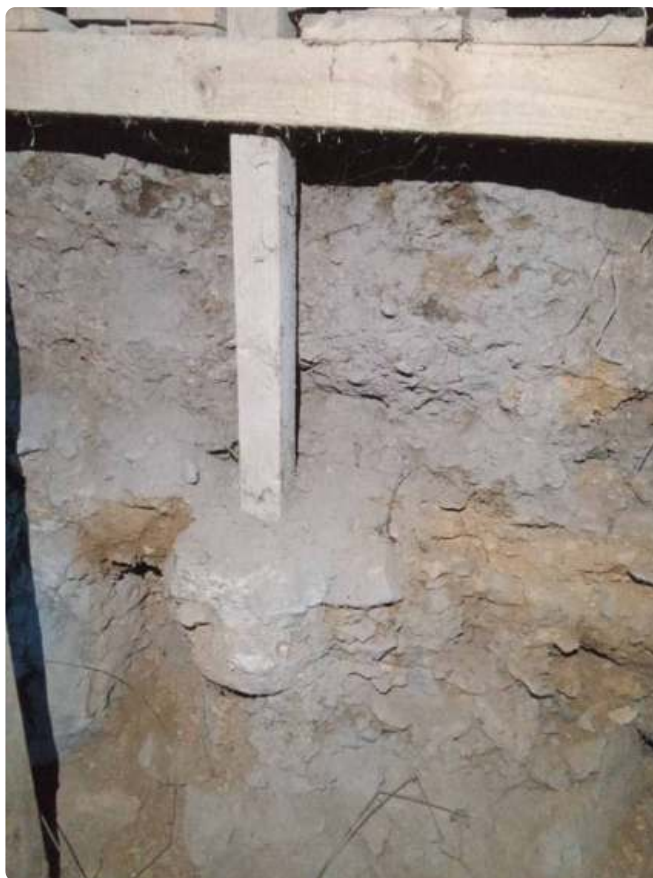
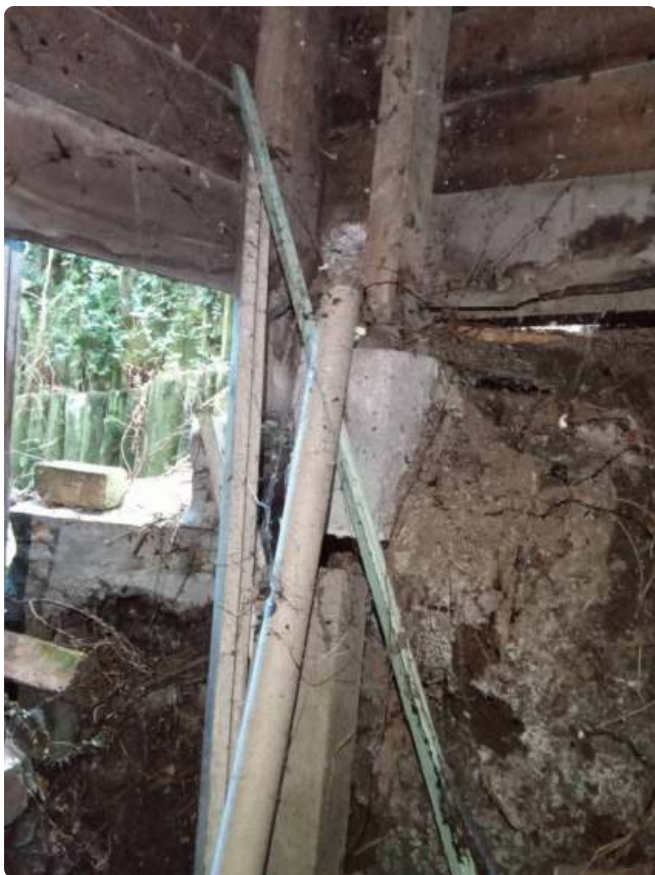
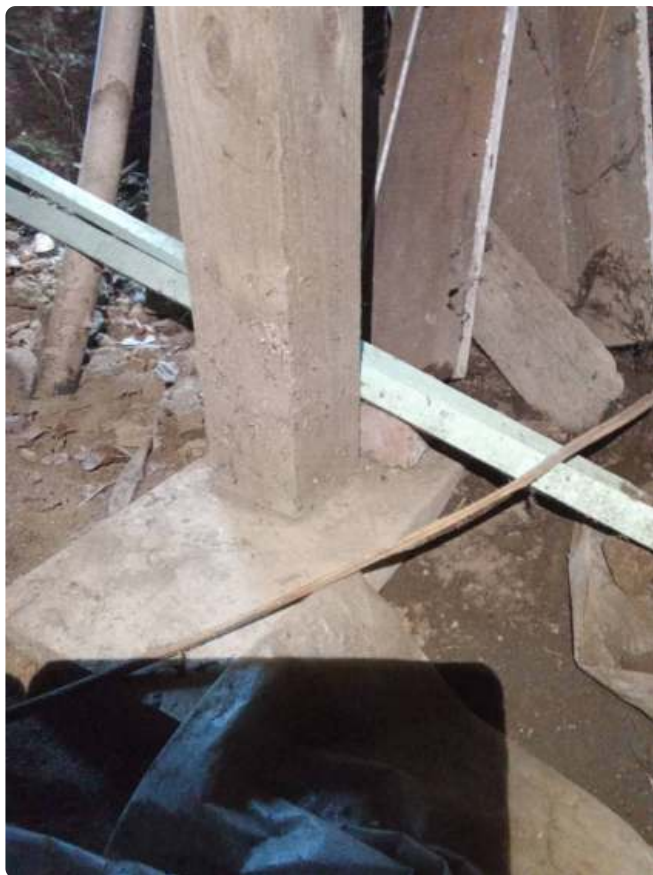
## Subfloor Type - Continued

Some of the timber piles are undermined when the extension was built. So is the chimney foundation.

Immediate attention required to rectify. Engineer to check.

- Engage a Chartered Professional Engineer immediately to assess and design repairs for the compromised subfloor and foundation in the extension area.
- Arrange a comprehensive invasive moisture/weathertightness assessment focused on extension joinery and wet areas.

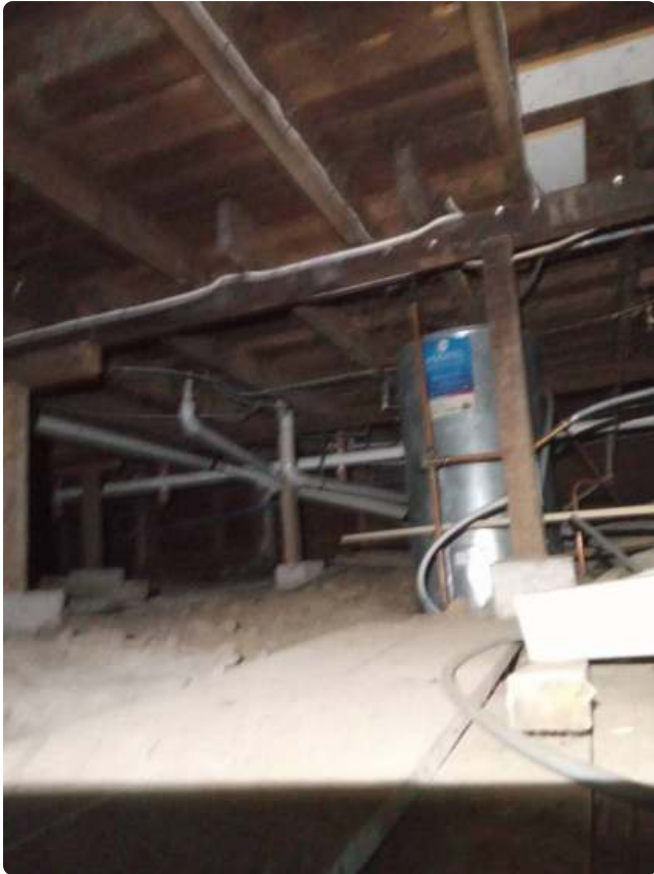
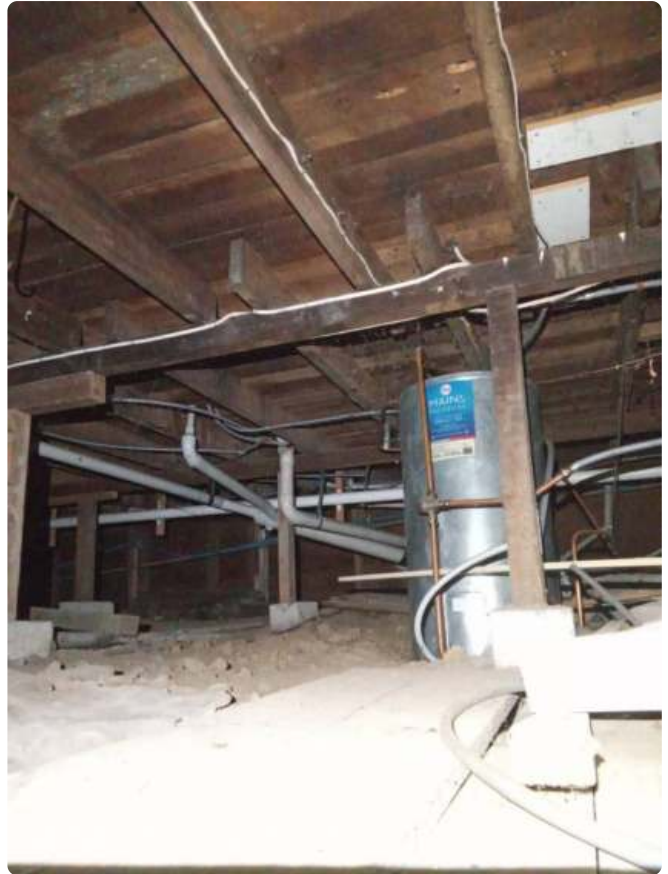
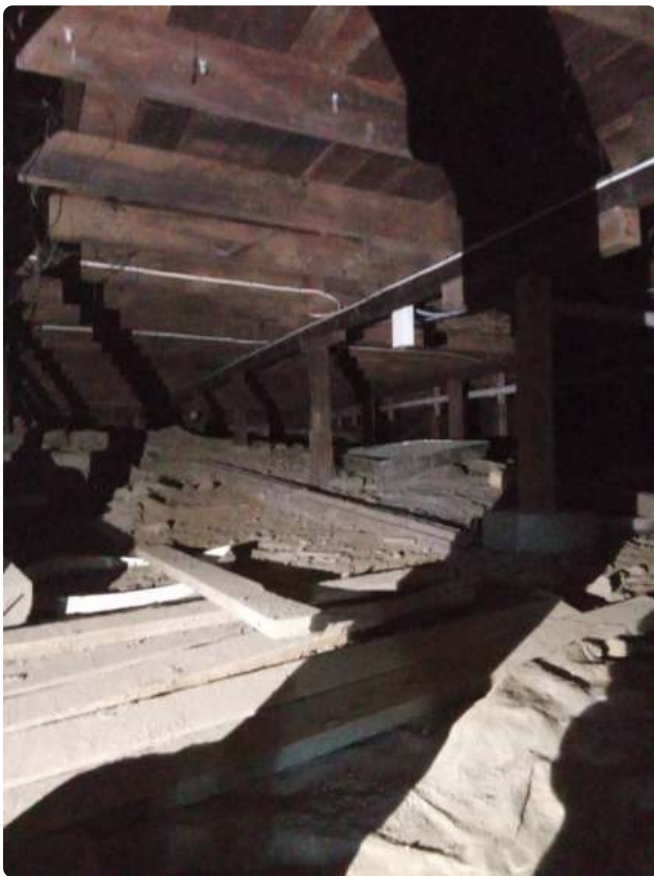
## Foundation Type - Continued

Timber piles foundation looks typical for the era. Main concern is the undermined extension area.

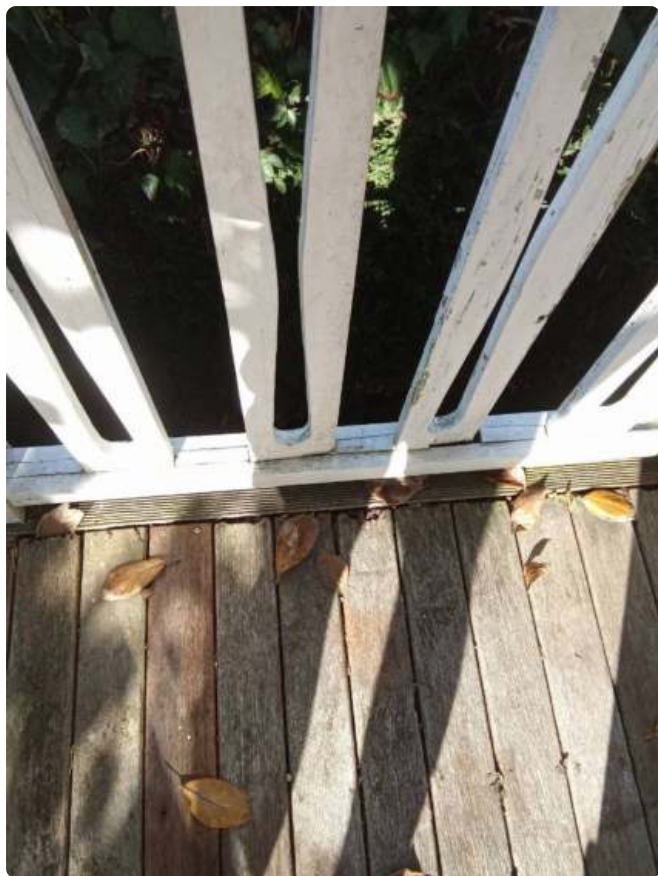
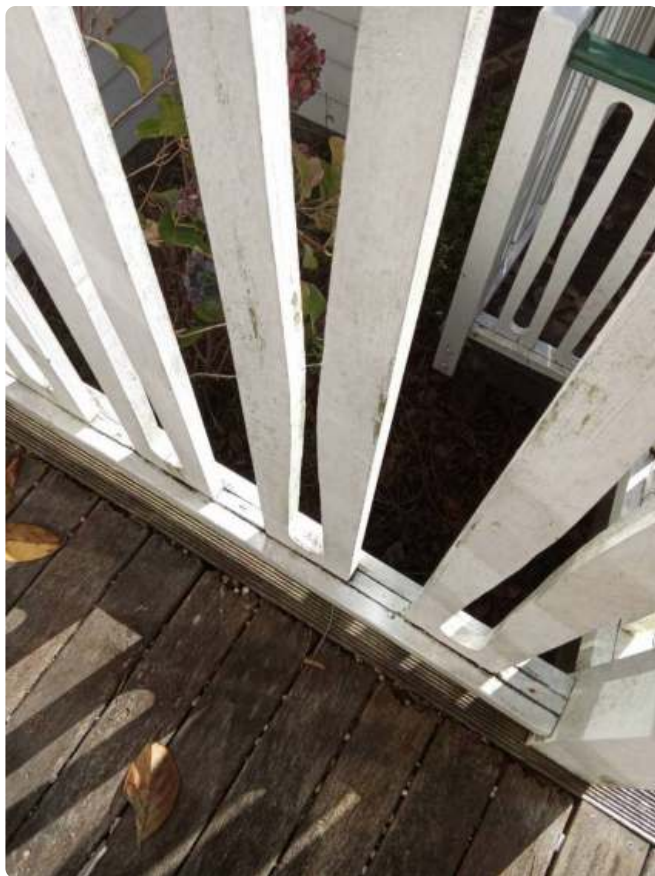
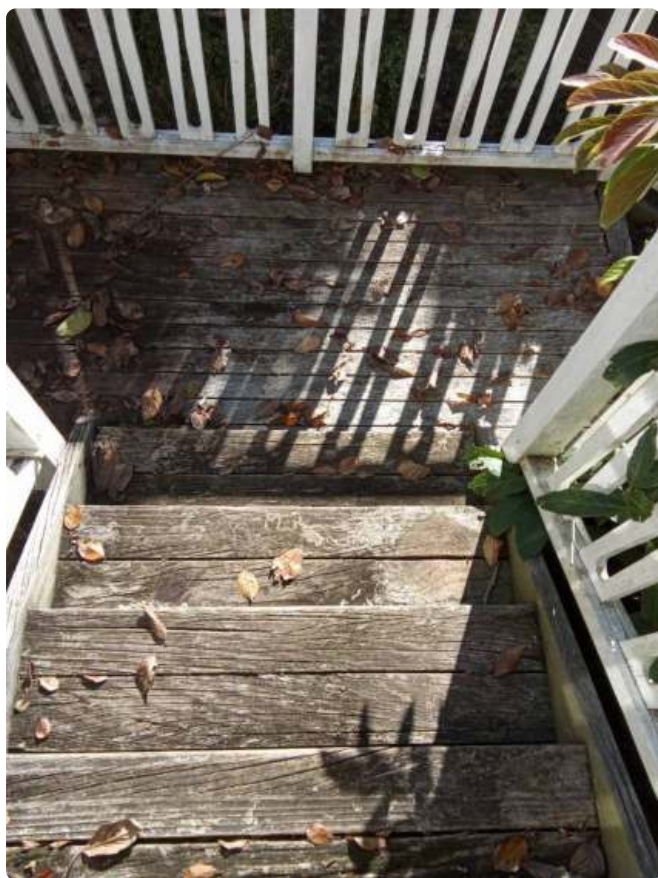
## Decking & Outdoor Structures - Continued

Rotten decking and balustrades. Also steps need replacing

Deck has rusted structural connections. Framing is covered with dirt and moss, needs a deep clean to assess the structure. Decking boards rotten, balustrade not stable. Steps failing.

- Replace all rotten decking, balustrades, and exterior stairs to ensure safety.
- Rectify ground clearance deficiencies to cladding and improve site drainage in affected zones.

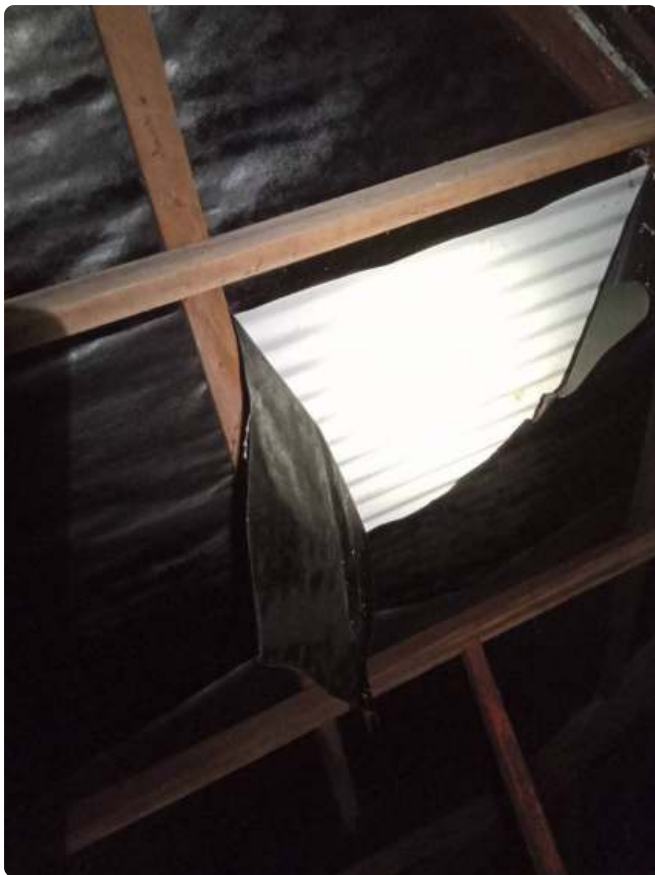
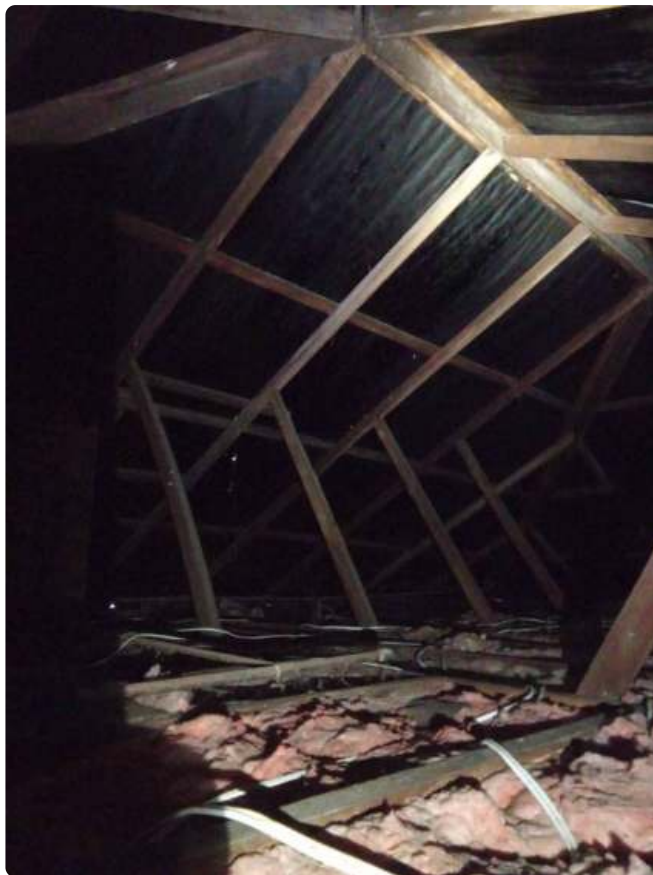
## Underlay/Sarking - Continued

| Access & Accessibility | |
|---|---|
| Roof underlay damaged | |

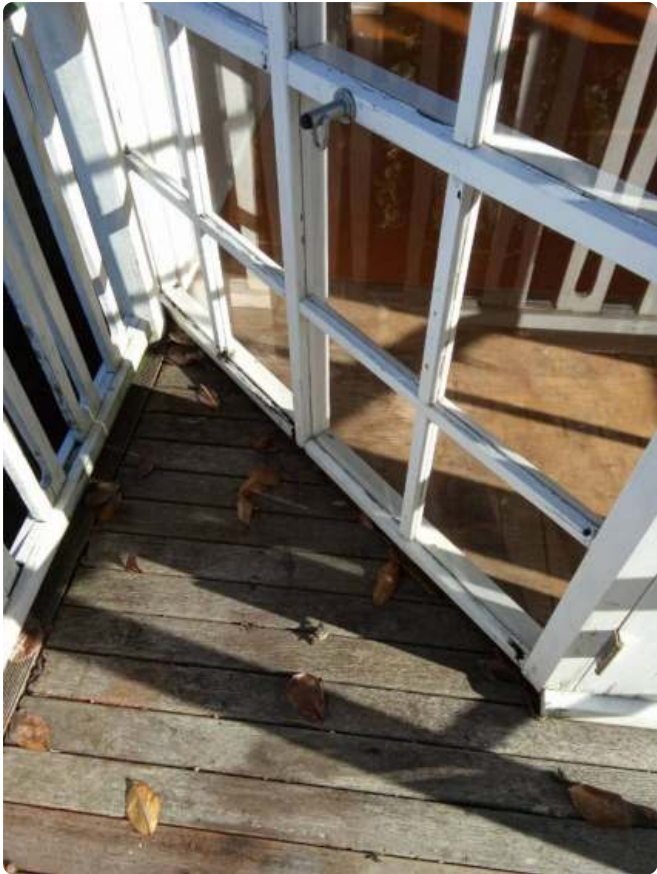
Deck & Balcony Junctions - Continued

| Condition | Major Defect |

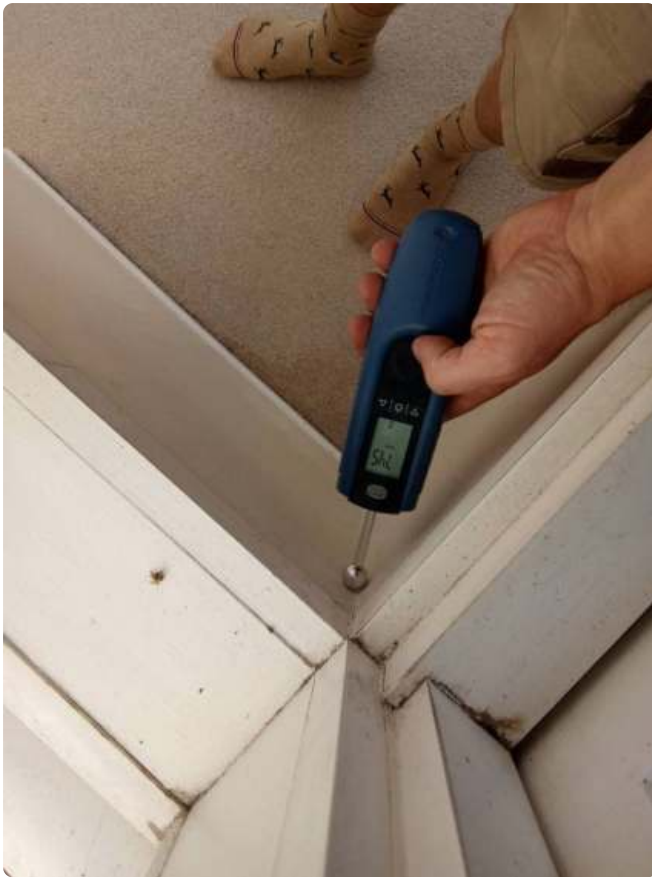
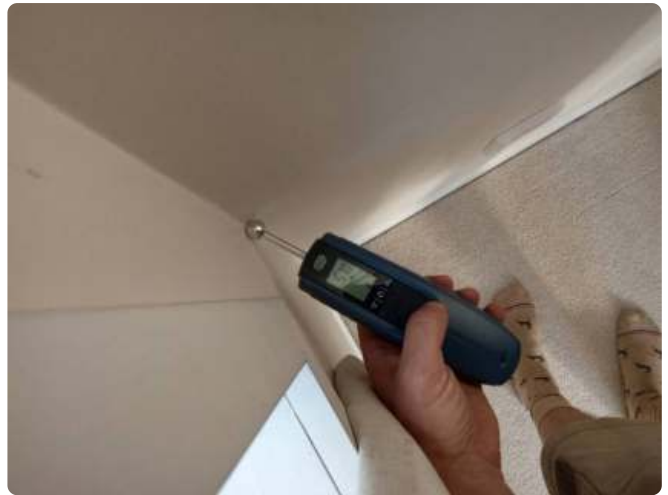
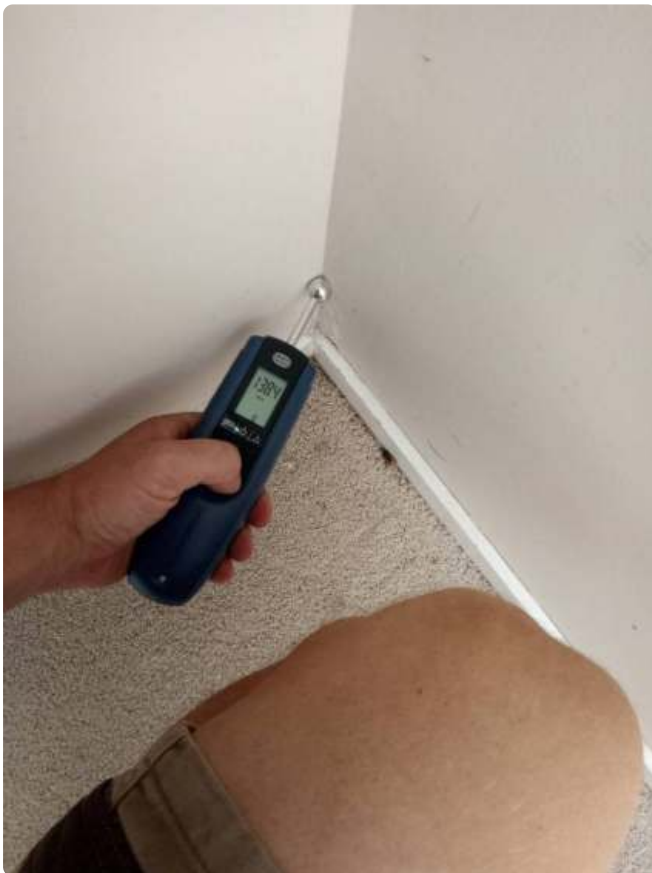
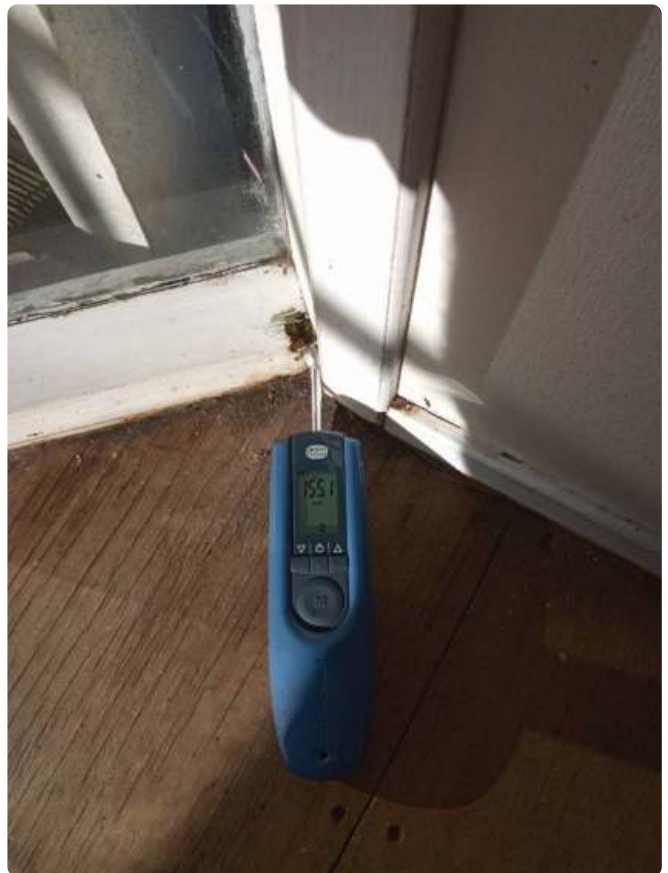
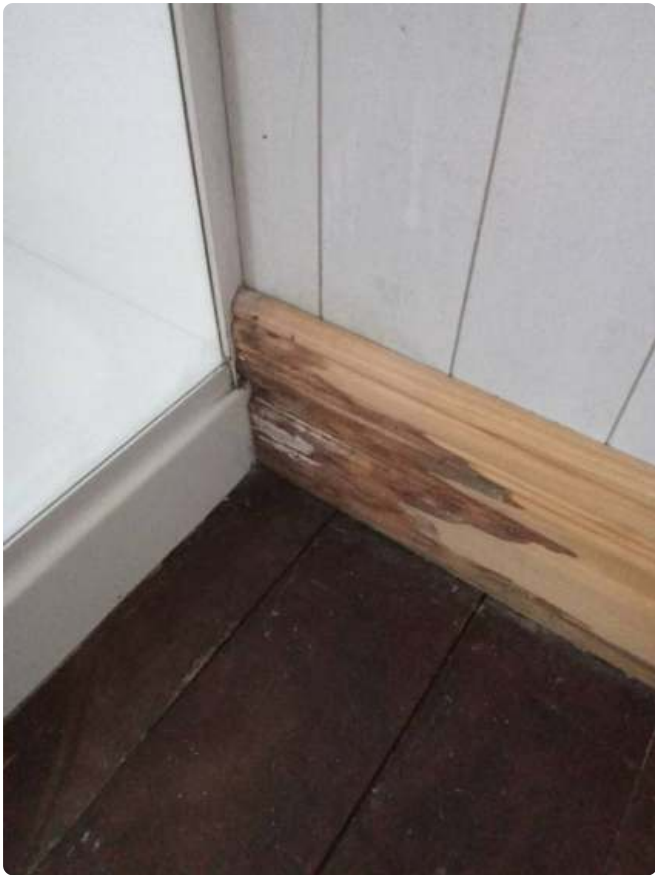
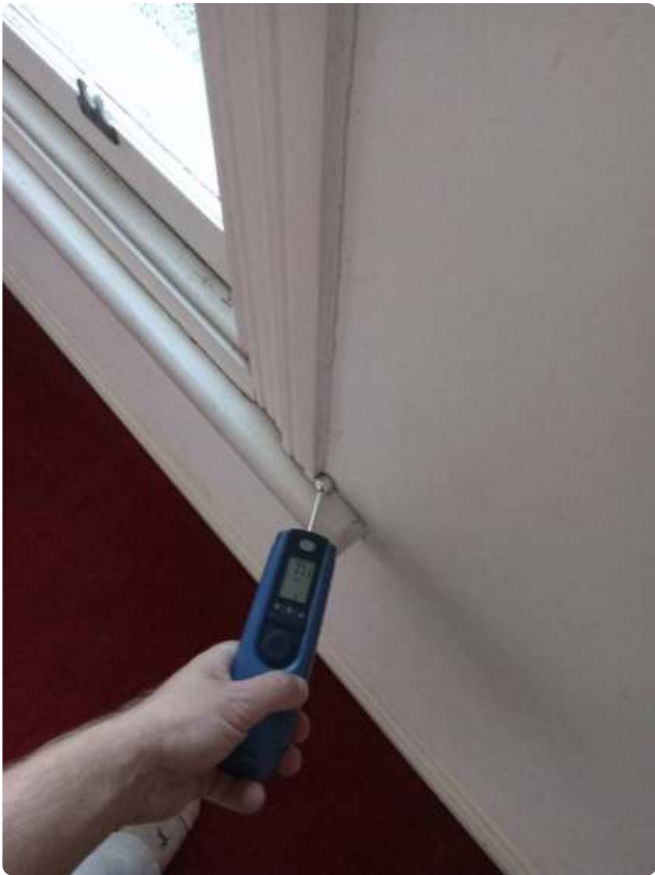
## Evidence Of Moisture Ingress - Continued

Shower leaks. Some windows show elevated moisture readings.

Most concerns around extension part. More invasive inspection required.
